UNDERWATER BRIDGE INSPECTION REPORT

STRUCTURE NO. 30508

RUM RIVER

DISTRICT 3 - ISANTI COUNTY

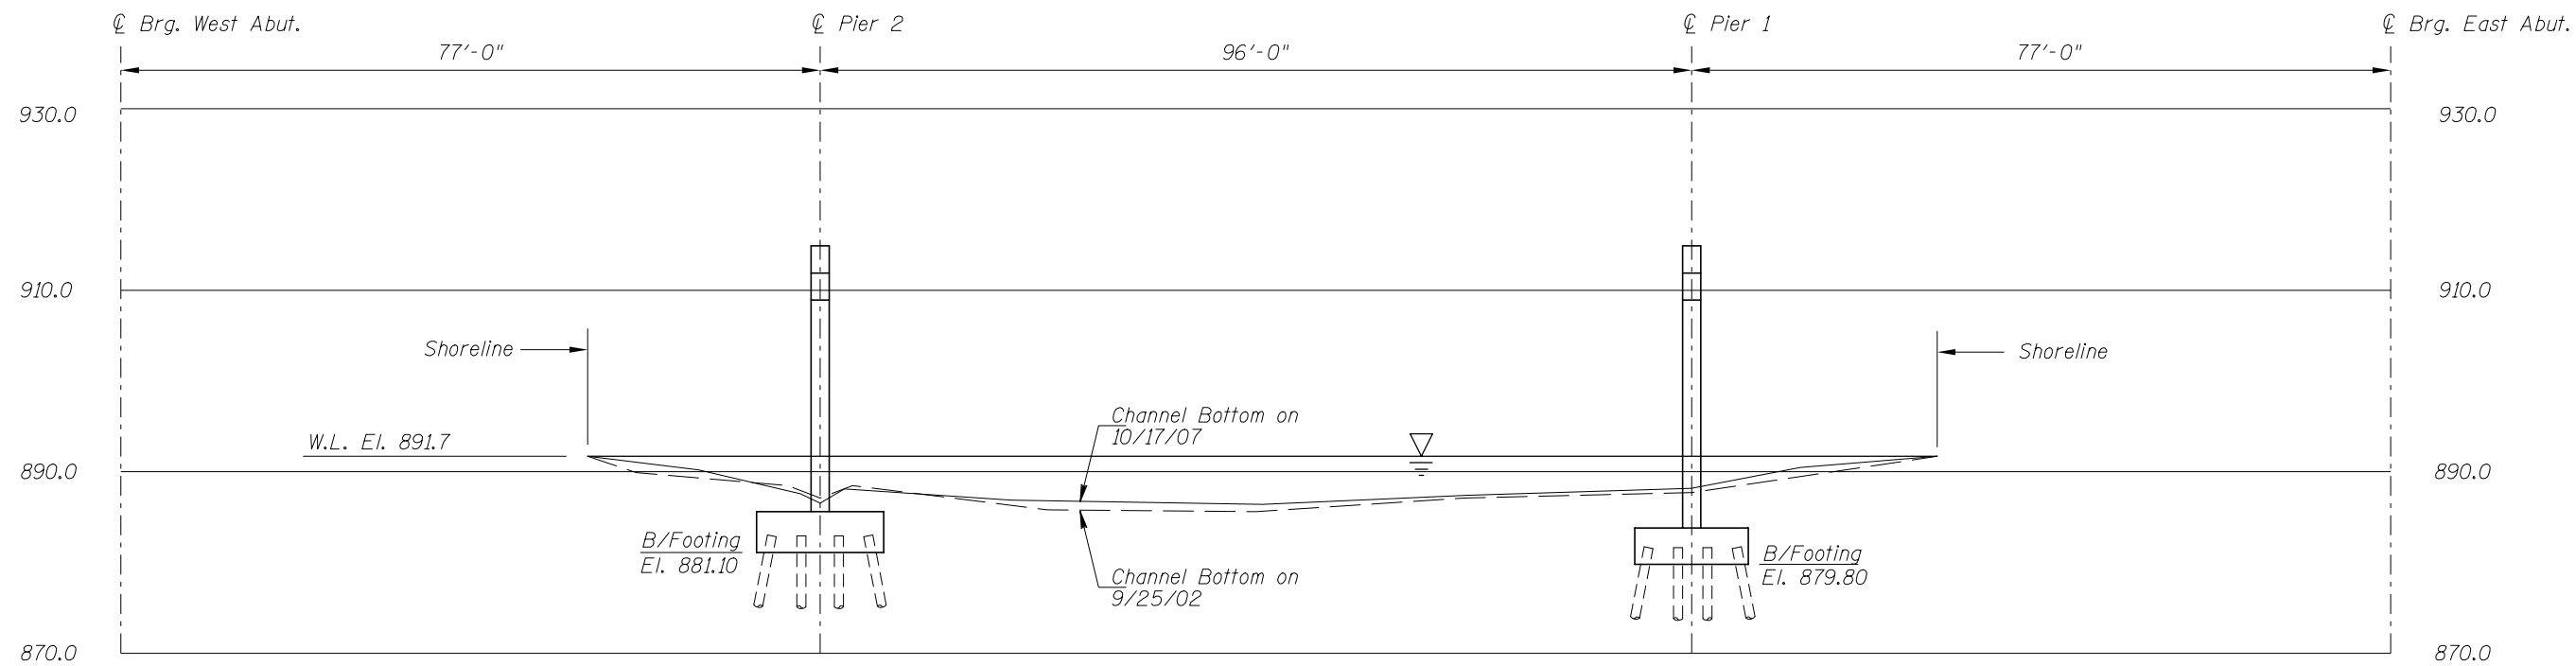
UPSTREAM FASCIA PROFILE

- The channel bottom consisted of 8- to 12-inch-diameter riprap and sand, with no appreciable probe rod penetration.
- The channel bottom consisted of firm sandy gravel with probe rod penetrations of 2 to 3 inches.
- The concrete surface was in smooth and sound condition with light scaling from 1 foot above to 1 foot below the waterline with up to 1/8 inch of penetration.
- A minor scour depression, 2 feet in radius by 6 inches deep, was observed around upstream nose of Pier 2.
